**Flood Control Project Maintenance
Levee Inspections**

2016 Channel Summary Report

San Joaquin County Flood Control and Water Conservation District

Flood Control Project Maintenance**Unit Cover Sheet****2016 Channel Inspection Results****San Joaquin County Flood Control and Water Conservation District**

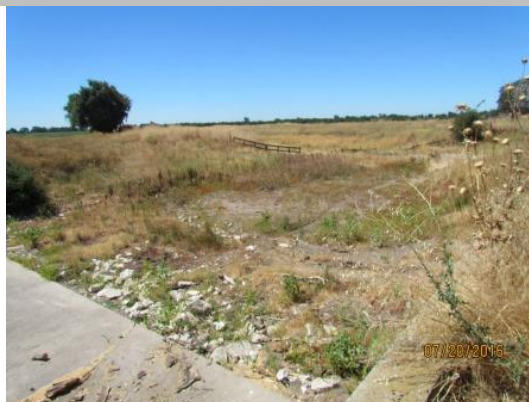
Photo 1 of 1 : CH_2016_NA0017_43_31_20160801_00013.jpg

Inspector Comments: Minimal vegetation in the channel should not impede the flow.

View of the vegetation in the diversion channel looking downstream during 2016 inspection.

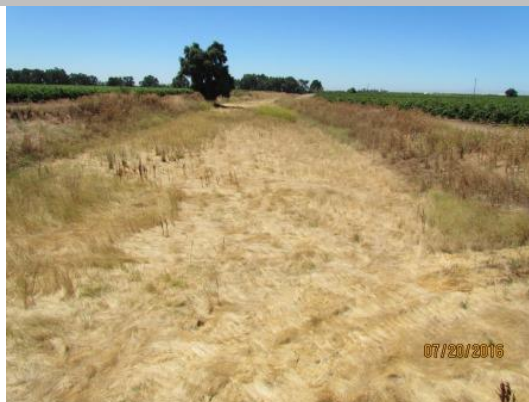
Photo 1 of 1 : CH_2016_NA0017_43_16_20160801_00017.jpg

Inspector Comments: Minimal vegetation is present in the channel but it doesn't appear to obstruct the flow of the channel.

View of the vegetation looking downstream of the channel.

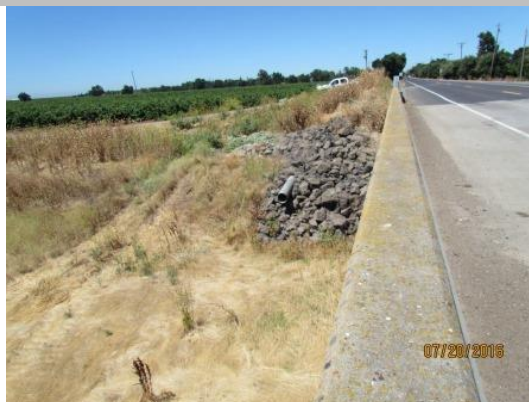
Photo 1 of 2 : CH_2016_NA0017_43_19_20160801_00018.jpg

Rating **	A	Issue No.	19	GPS Lat/Long
Issue Type +	Ma	Location *		37.929807 °
Category	Rivers, Channels & Designated Flood			-120.991183 °
Item	Revetments			
DWR ID	DWR_NA0017_43_c_2012_19			
Action/Comments				
Inspector Comments: Existing riprap appears to be properly maintained.

View of the revetments on the right bank of the channel looking downstream.

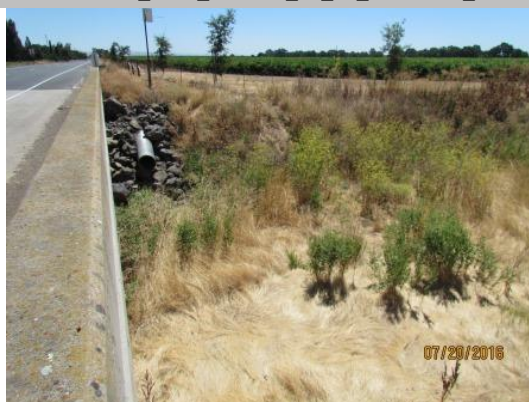
Photo 2 of 2 : CH_2016_NA0017_43_19_20160801_00019.jpg

View of the revetments on the left bank of the channel looking downstream.

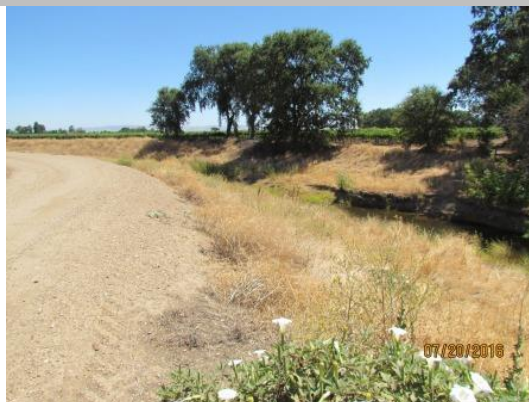
Photo 1 of 4 : CH_2016_NA0017_43_21_20160801_00021.jpg

Inspector Comments: Vegetation growth in the channel doesn't appeared to impede the flow.

View of the channel looking upstream during 2016 inspection.

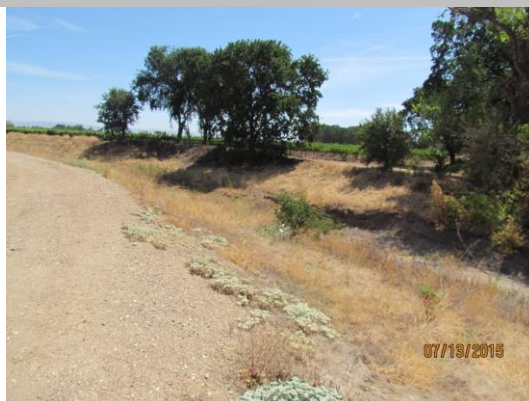
Photo 3 of 4 : CH_2016_NA0017_43_21_20160613_00007.jpg

View of the channel looking upstream during 2015 inspection.

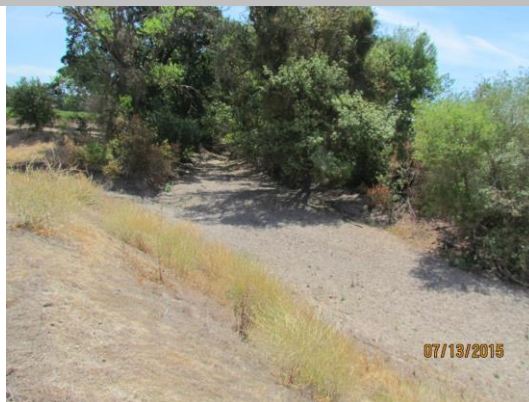
Photo 4 of 4 : CH_2016_NA0017_43_21_20160613_00009.jpg

Inspector Comments: Vegetation growth in the channel doesn't appeared to impede the flow.

View of the confluence during 2015 inspection.

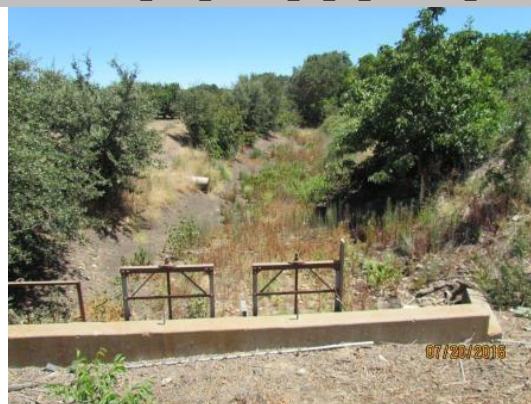
Photo 1 of 2 : CH_2016_NA0017_42_11_20160802_00034.jpg

Inspector Comments: Minimal vegetation exist, but it will not impede the flow of the channel.

View of the channel looking upstream during 2016 inspection.

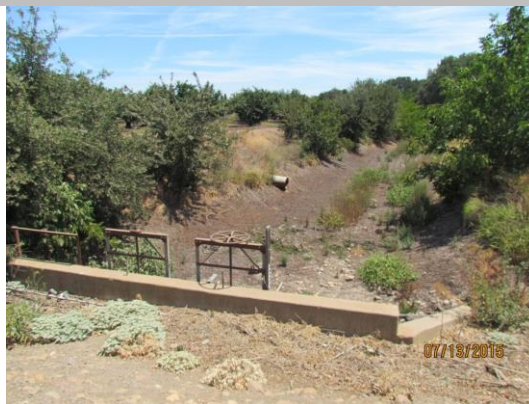
Photo 2 of 2 : CH_2016_NA0017_42_11_20160613_00002.jpg

Rating **	A	Issue No.	11 (cont)	GPS Lat/Long
Issue Type +	Ma	Location *		37.920600 °
Category	Rivers, Channels & Designated Flood			-121.037920 °
Item	Vegetation & Obstructions			
DWR ID	DWR_NA0017_42_c_2012_11			
Action/Comments				
Inspector Comments: Minimal vegetation exist, but it will not impede the flow of the channel.

View of the channel looking upstream during 2015 inspection.

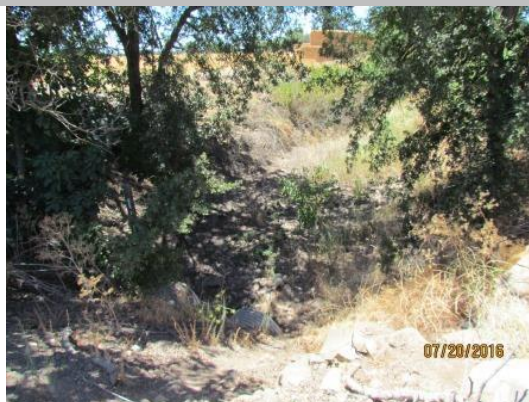
Photo 1 of 2 : CH_2016_NA0017_42_16_20160802_00037.jpg

Rating **	A	Issue No.	16	GPS Lat/Long
Issue Type +	Ma	Location *		37.920584 °
Category	Rivers, Channels & Designated Flood			-121.037914 °
Item	Vegetation & Obstructions			
DWR ID	DWR_NA0017_42_c_2012_16			
Action/Comments				
Inspector Comments: Walnut tree exists on left side of the shoulder. It doesn't obstructed the flow, but it could fall down in the creek.

View of the vegetation on the channel looking downstream during 2016 inspection.

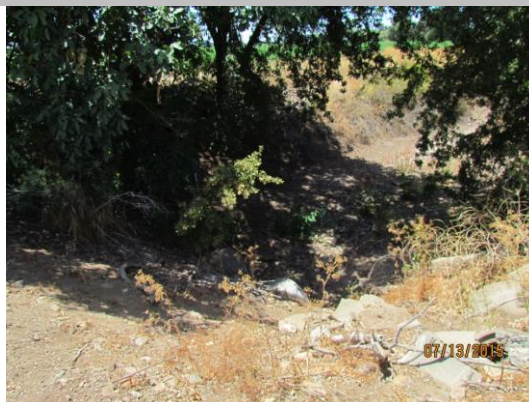
Photo 2 of 2 : CH_2016_NA0017_42_16_20160613_00004.jpg

View of the channel looking downstream during 2015 inspection.

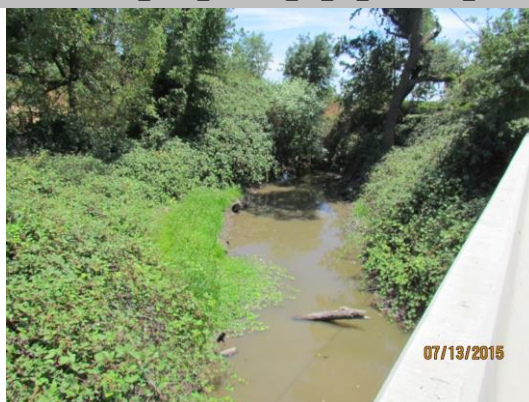
Photo 2 of 2 : CH_2016_NA0017_42_21_20160613_00005.jpg

Inspector Comments: Tree branches and vegetation growth on the channel may cause an obstruction in the flow.

View of the vegetation looking upstream of the channel.

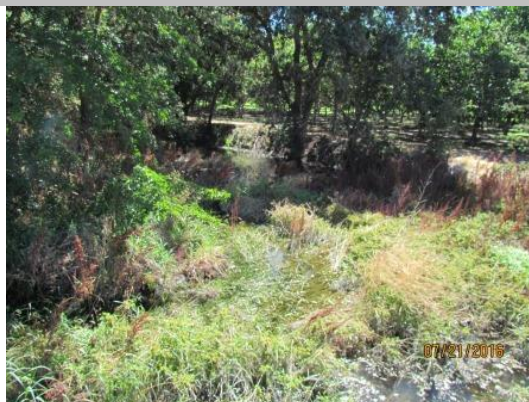
Photo 1 of 1 : CH_2016_NA0017_42_31_20160802_00041.jpg

Inspector Comments: Vegetation exists on the channel, and woody vegetation may obstruct the flow of the channel.

View of the channel looking upstream during 2016 inspection.

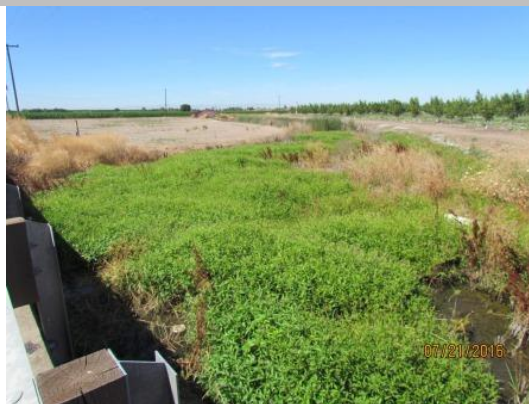
Photo 1 of 1 : CH_2016_NA0017_42_36_20160802_00043.jpg

Rating **	A	Issue No.	36	GPS Lat/Long
Issue Type +	Ma	Location *		37.921460 °
Category	Rivers, Channels & Designated Flood			-121.147570 °
Item	Vegetation & Obstructions			
DWR ID	DWR_NA0017_42_c_2012_36			
Action/Comments				
Inspector Comments: Minimal vegetation on the channel should not obstruct the flow.

View of the channel looking downstream.

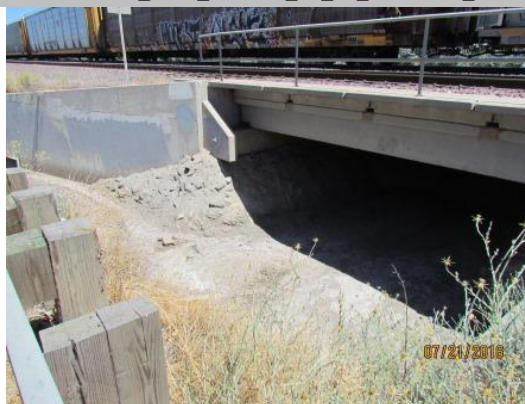
Photo 1 of 2 : CH_2016_NA0017_42_41_20160802_00044.jpg

Inspector Comments: Minimal vegetation on the channel should not impede the flow.

View of upstream of the channel during 2016 inspection.

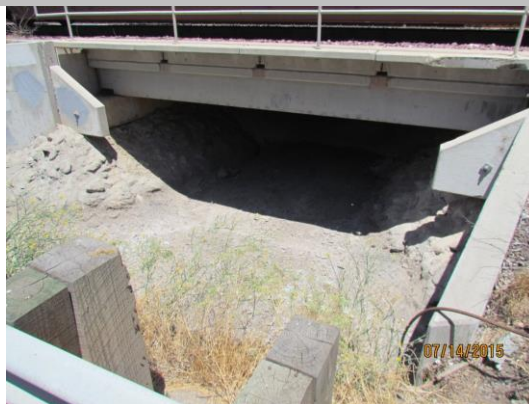
Photo 2 of 2 : CH_2016_NA0017_42_41_20160613_00011.jpg

Inspector Comments: Minimal vegetation on the channel should not impede the flow.

View of upstream of the channel during 2015 inspection.

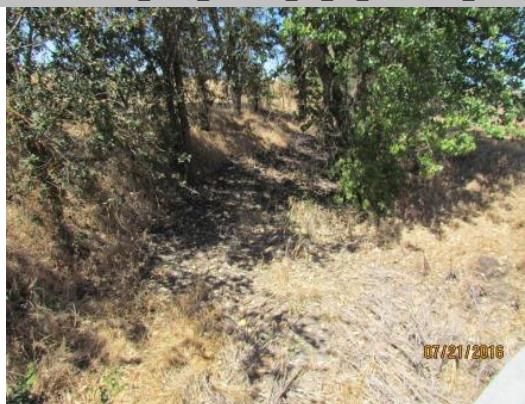
Photo 1 of 1 : CH_2016_NA0017_42_46_20160802_00045.jpg

Inspector Comments: Vegetation growth may obstruct the flow of the channel.

View of vegetation on the downstream of the channel.

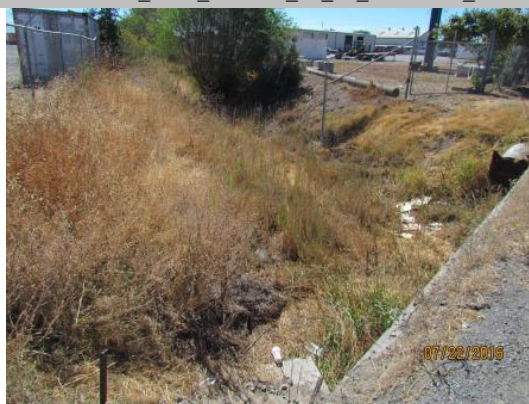
Photo 1 of 2 : CH_2016_NA0017_42_51_20160803_00047.jpg

Inspector Comments: Minimal vegetation on the channel may impede the flow of the channel.

View of the vegetation on the channel looking upstream during 2016 inspection.

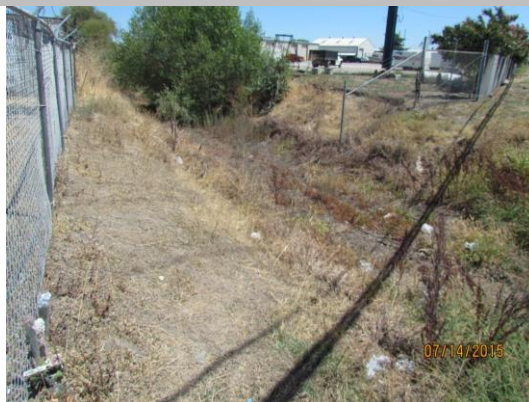
Photo 2 of 2 : CH_2016_NA0017_42_51_20160613_00015.jpg

Rating **	M	Issue No.	51 (cont)	GPS Lat/Long
Issue Type +	Ma	Location *		37.913239 °
Category	Rivers, Channels & Designated Flood			-121.225915 °
Item	Vegetation & Obstructions			
DWR ID	DWR_NA0017_42_c_2012_51			
Action/Comments				
Inspector Comments: Minimal vegetation on the channel may impede the flow of the channel.

View of the vegetation on the channel looking upstream during 2015 inspection.

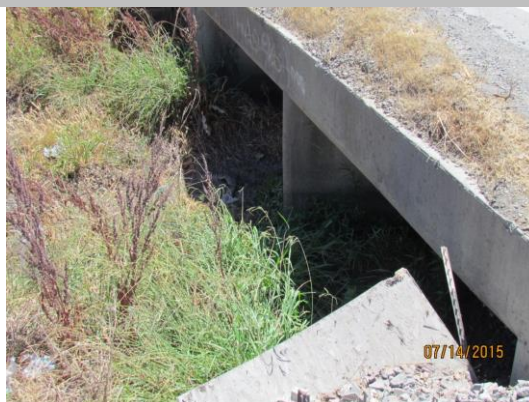
Photo 1 of 1 : CH_2016_NA0017_42_52_20160613_00017.jpg

Rating **	M	Issue No.	52	GPS Lat/Long
Issue Type +	Ma	Location *		37.913239 °
Category	Rivers, Channels & Designated Flood			-121.225915 °
Item	Shoaling / Sedimentation			
DWR ID	DWR_NA0017_42_c_2012_52			
Action/Comments				
Inspector Comments: Sedimentation is present at this location.

View of sedimentation on the upstream of the channel.

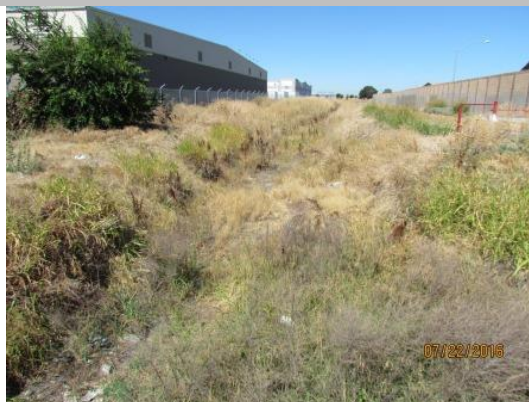
Photo 1 of 2 : CH_2016_NA0017_42_56_20160803_00049.jpg

Inspector Comments: Minimal vegetation does not impede the flow on the channel.

View of the channel looking downstream during 2016 inspection.

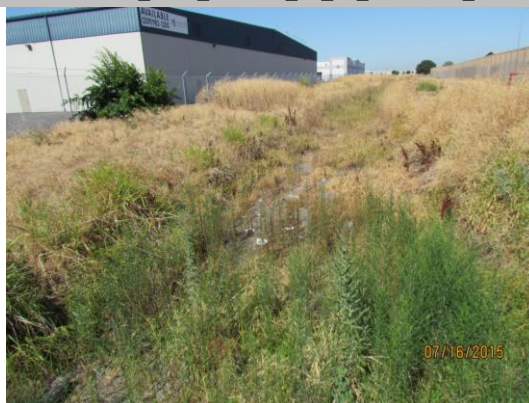
Photo 2 of 2 : CH_2016_NA0017_42_56_20160613_00019.jpg

View of the downstream end of the channel.

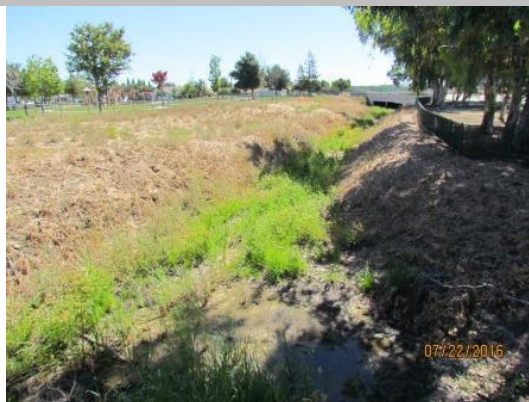
Photo 1 of 2 : CH_2016_NA0017_42_61_20160803_00050.jpg

Inspector Comments: Minimal vegetation may not impede the flow of the channel.

View of the channel looking upstream during 2016 inspection.

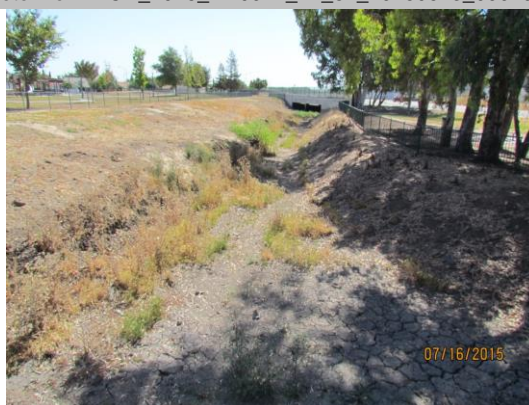
Photo 2 of 2 : CH_2016_NA0017_42_61_20160613_00020.jpg

View of the channel looking upstream during 2015 inspection.

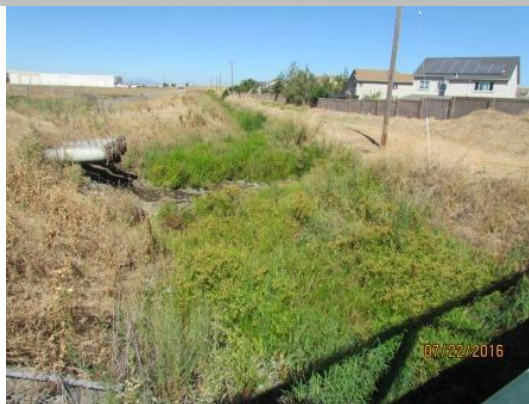
Photo 1 of 2 : CH_2016_NA0017_42_66_20160803_00051.jpg

Inspector Comments: Minimal vegetation may not impede the flow of the channel.

View of the vegetation looking downstream of the channel during 2016 inspection.

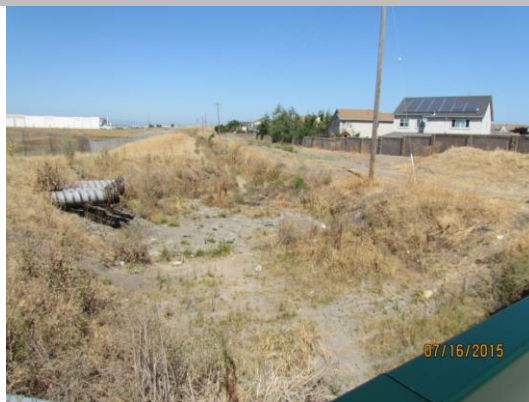
Photo 2 of 2 : CH_2016_NA0017_42_66_20160613_00022.jpg

View of the channel looking downstream.

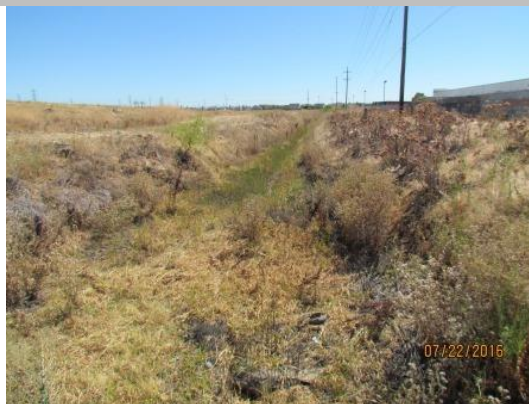
Photo 1 of 2 : CH_2016_NA0017_42_71_20160803_00052.jpg

Inspector Comments: Minimal vegetation is present in the channel.

View of vegetation on the channel looking upstream during 2016 inspection.

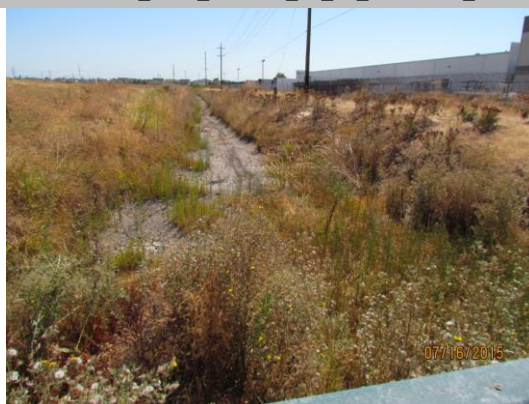
Photo 2 of 2 : CH_2016_NA0017_42_71_20160613_00023.jpg

View of vegetation on the channel looking upstream.

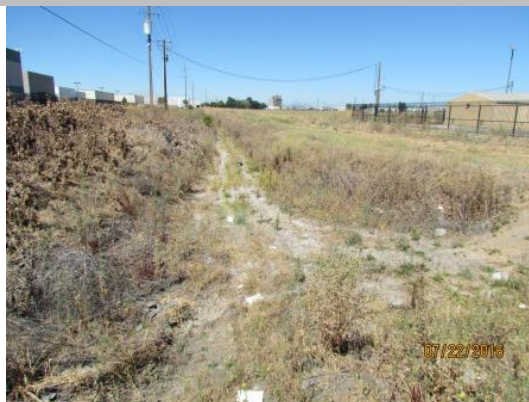
Photo 1 of 2 : CH_2016_NA0017_42_76_20160803_00053.jpg

Inspector Comments: Minimal vegetation on the channel may not impede the flow.

View of the vegetation looking downstream during 2016 inspection.

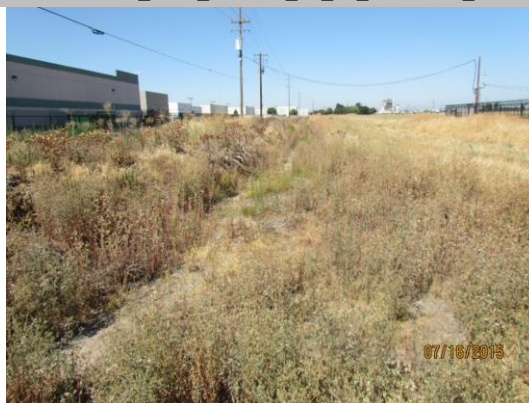
Photo 2 of 2 : CH_2016_NA0017_42_76_20160613_00024.jpg

View of the channel looking downstream on 2015 inspection.

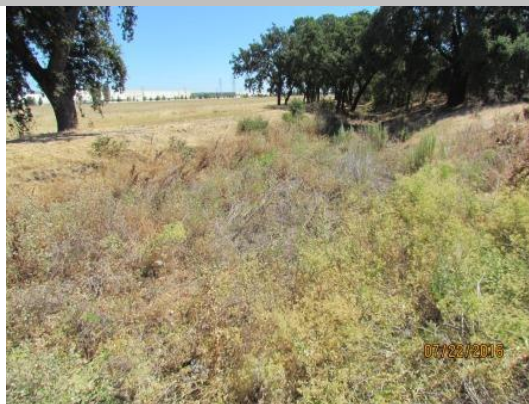
Photo 1 of 1 : CH_2016_NA0017_42_81_20160803_00054.jpg

Rating **	M	Issue No.	81	GPS Lat/Long
Issue Type +	Ma	Location *		37.912070 °
Category	Rivers, Channels & Designated Flood			-121.258811 °
Item	Vegetation & Obstructions			
DWR ID	DWR_NA0017_42_c_2012_81			
Action/Comments				
Inspector Comments: Moderate vegetation present in channel may impede the flow.

View of the vegetation on the channel looking upstream.

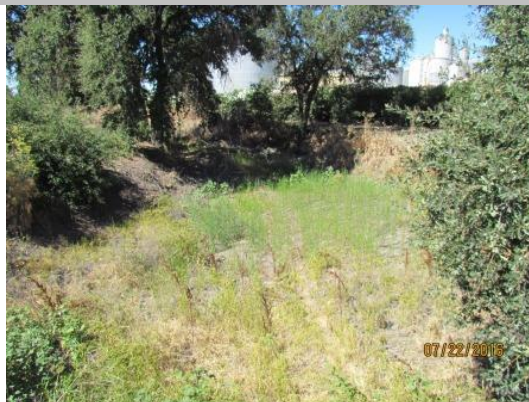
Photo 1 of 2 : CH_2016_NA0017_42_86_20160803_00055.jpg

Inspector Comments: Moderate woody vegetation may impede the flow of the channel.

View of the vegetation on the channel looking downstream during 2016 inspection.

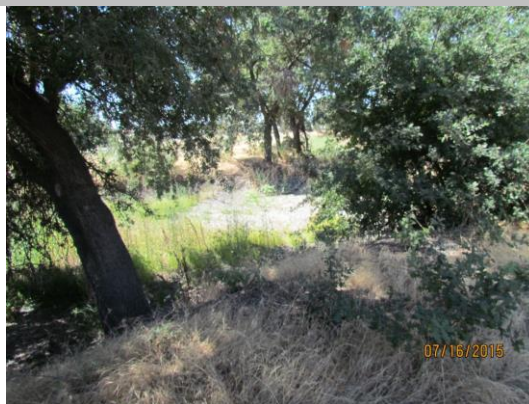
Photo 2 of 2 : CH_2016_NA0017_42_86_20160613_00027.jpg

Rating **	M	Issue No.	86 (cont)	GPS Lat/Long
Issue Type +	Ma	Location *		37.912070 °
Category	Rivers, Channels & Designated Flood			-121.258811 °
Item	Vegetation & Obstructions			
DWR ID	DWR_NA0017_42_c_2012_86			
Action/Comments				
Inspector Comments: Moderate woody vegetation may impede the flow of the channel.

View of the channel looking downstream.

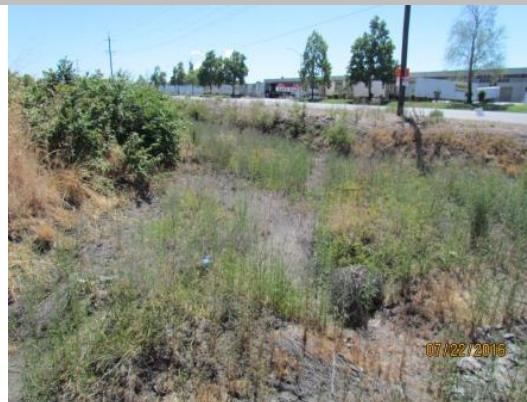
Photo 1 of 1 : CH_2016_NA0017_42_91_20160803_00056.jpg

Inspector Comments: Minimal vegetation may not impede the flow of the channel.

View of the channel looking upstream.

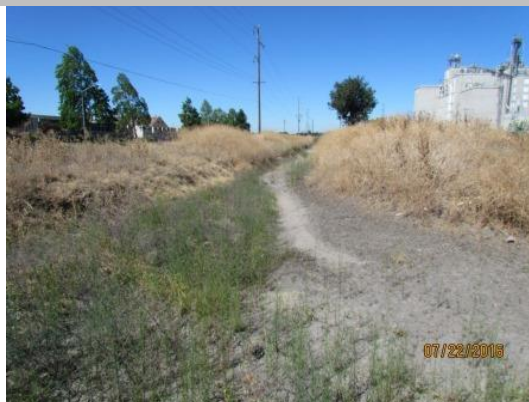
Photo 1 of 2 : CH_2016_NA0017_42_96_20160803_00057.jpg

Inspector Comments: Minimal vegetation was found, but the flow is not impeded.

View of the channel looking downstream during 2016 inspection.

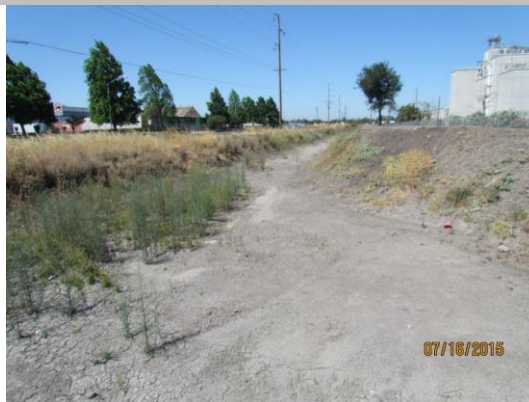
Photo 2 of 2 : CH_2016_NA0017_42_96_20160613_00029.jpg

View of the channel looking downstream.

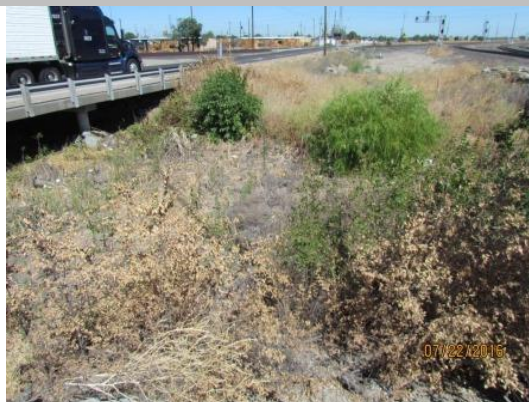
Photo 1 of 2 : CH_2016_NA0017_42_101_20160803_00058.jpg

Check Point / View				
McKinley Avenue / Up				
Rating **	M	Issue No.	101	GPS Lat/Long
Issue Type +	Ma	Location *		37.907158 °
Category	Rivers, Channels & Designated Flood			-121.273935 °
Item	Vegetation & Obstructions			
DWR ID	DWR_NA0017_42_c_2012_101			
Action/Comments				
Inspector Comments: Vegetation, logs and other debris may impede the flow of the channel.

View of the heavy vegetation on the channel looking upstream during 2016 inspection.

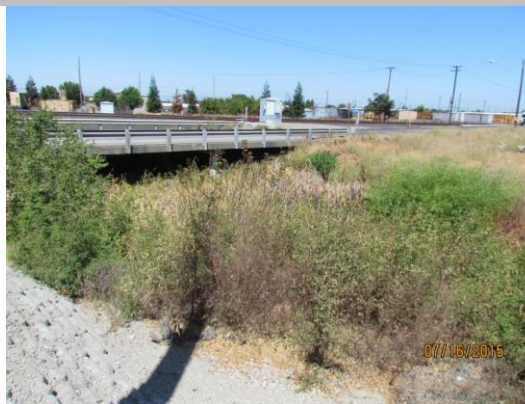
Photo 2 of 2 : CH_2016_NA0017_42_101_20160613_00030.jpg

Inspector Comments: Vegetation, logs and other debris may impede the flow of the channel.

View of the heavy vegetation on the channel looking upstream.

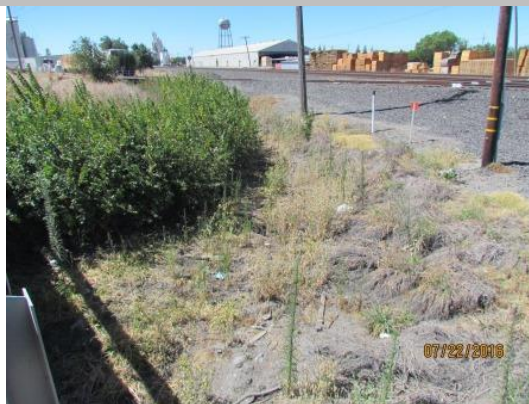
Photo 1 of 2 : CH_2016_NA0017_42_106_20160803_00060.jpg

Inspector Comments: Vegetation and debris may impede the flow of the channel.

View of the channel looking downstream during 2016 inspection.

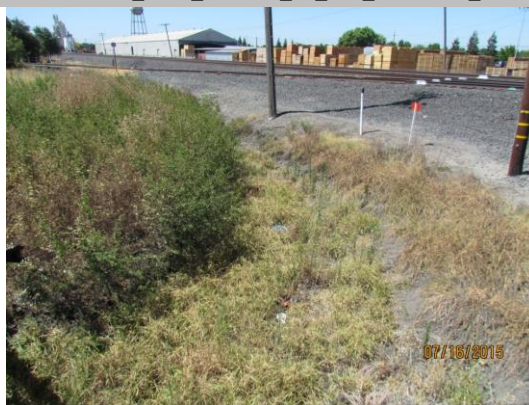
Photo 2 of 2 : CH_2016_NA0017_42_106_20160613_00031.jpg

View of the vegetation looking downstream of the channel.

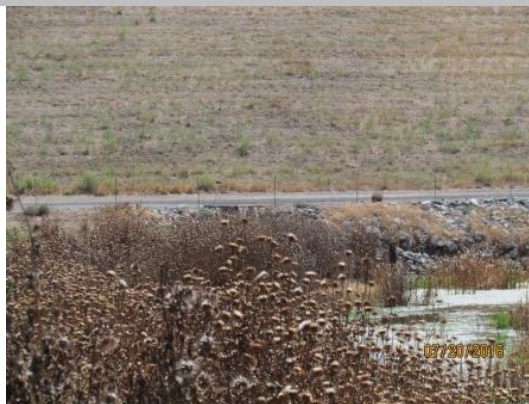
Photo 1 of 1 : CH_2016_NA0017_44_119_20160726_00051.jpg

Rating **	A	Issue No.	119	GPS Lat/Long
Issue Type +	Ma	Location *		37.900580 °
Category	Rivers, Channels & Designated Flood			-120.936018 °
Item	Gates			
DWR ID	DWR_NA0017_44_c_2014_119			
Action/Comments				
Inspector Comments: The gate appears to be functional.

View of the release gate from Farmington Dam looking upstream of the creek.

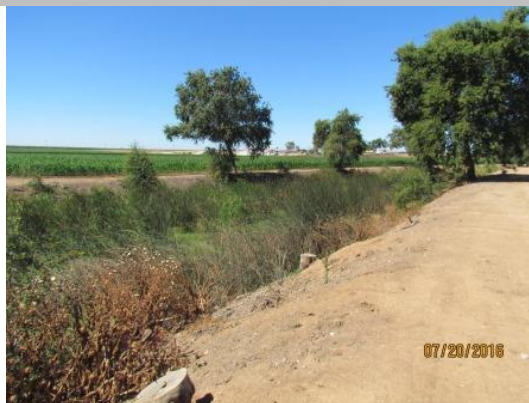
Photo 1 of 1 : CH_2016_NA0017_44_6_20160726_00052.jpg

Rating **	M	Issue No.	6	GPS Lat/Long
Issue Type +	Ma	Location *		37.914340 °
Category	Rivers, Channels & Designated Flood			-120.937860 °
Item	Vegetation & Obstructions			
DWR ID	DWR_NA0017_44_c_2012_6			
Action/Comments				
Inspector Comments: Vegetation in the channel may impede the flow.

View of the vegetation on the channel looking downstream.

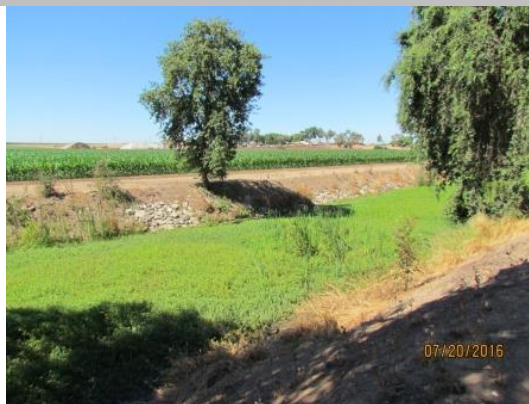
Photo 1 of 1 : CH_2016_NA0017_44_9_20160726_00054.jpg

Check Point / View				
Farmington Dam / Down (cont)				
Rating **	A	Issue No.	9	GPS Lat/Long
Issue Type +	Ma	Location *		37.900914 °
Category	Rivers, Channels & Designated Flood			-120.934604 °
Item	Revetments			
DWR ID	DWR_NA0017_44_c_2012_9			
Action/Comments				
Inspector Comments: Existing riprap appeared to be maintained.

View of the existing revetments looking downstream during 2016 inspection.

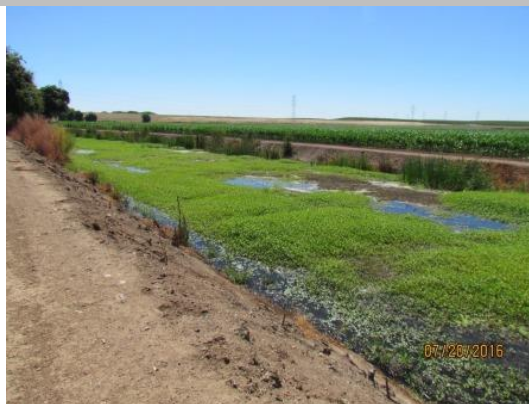
Photo 1 of 1 : CH_2016_NA0017_44_99_20160726_00055.jpg

Inspector Comments: Minimal vegetation may not impede the flow of the channel.

View of the vegetation on the channel looking upstream.

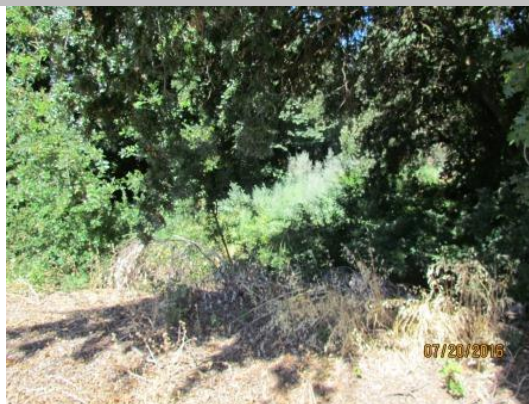
Photo 1 of 2 : CH_2016_NA0017_44_104_20160726_00057.jpg

Inspector Comments: Heavy vegetation growth will impede the flow and may block approximately 50% capacity of the channel.

View of the vegetation on the downstream of the channel during 2016 inspection.

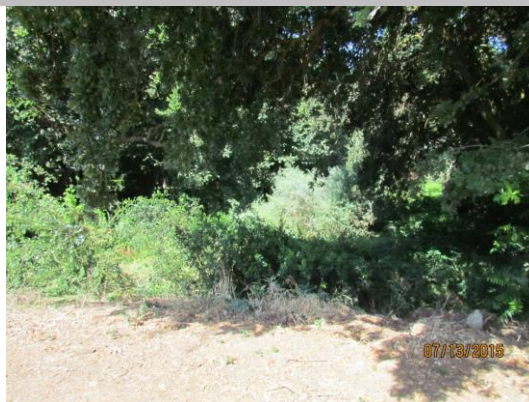
Photo 2 of 2 : CH_2016_NA0017_44_104_20160720_00040.jpg

Rating **	U	Issue No.	104 (cont)	GPS Lat/Long
Issue Type +	Ma	Location *		37.900332 °
Category	Rivers, Channels & Designated Flood			-120.939298 °
Item	Vegetation & Obstructions			
DWR ID	DWR_NA0017_44_c_2013_104

View of the vegetation on the downstream of the channel during 2015 inspection.

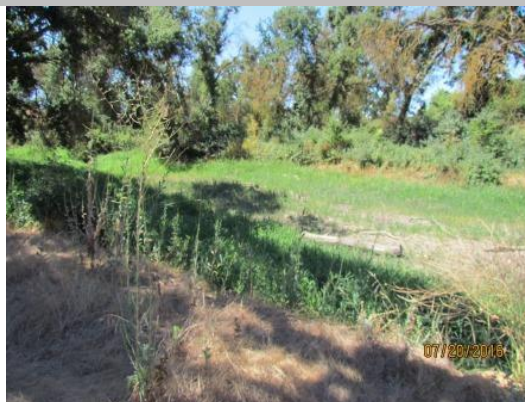
Photo 1 of 1 : CH_2016_NA0017_44_141_20160726_00058.jpg

Inspector Comments: Minimal vegetation was present, but the flow is not impeded.

View of vegetation on the upstream of the channel.

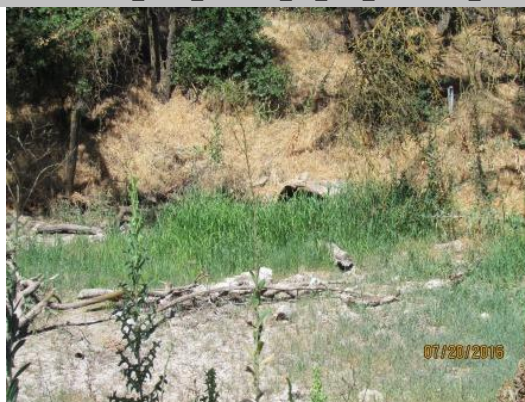
Photo 1 of 1 : CH_2016_NA0017_44_150_20160726_00059.jpg

Inspector Comments: The pipe appears to be free of debris and does not appear to impede the flow of the channel.

View of the pipe looking upstream from the channel.

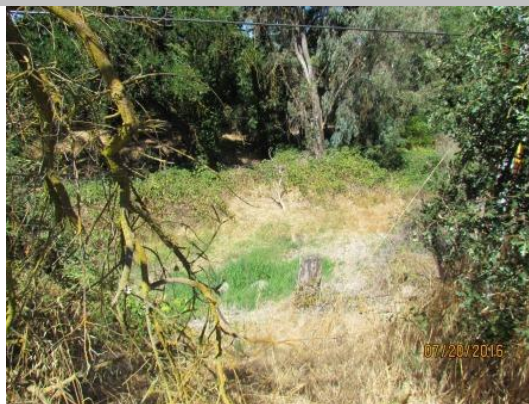
Photo 1 of 1 : CH_2016_NA0017_44_146_20160726_00061.jpg

Rating **	M	Issue No.	146	GPS Lat/Long
Issue Type +	Ma	Location *		37.903161 °
Category	Rivers, Channels & Designated Flood			-120.945289 °
Item	Vegetation & Obstructions			
DWR ID	DWR_NA0017_44_c_2015_146			
Action/Comments				
Inspector Comments: Vegetation growth may impede the flow of the channel.

View of the vegetation on the downstream of the channel.

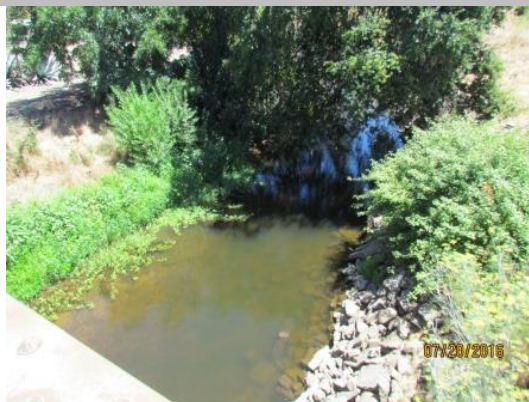
Photo 1 of 2 : CH_2016_NA0017_44_21_20160802_00062.jpg

Inspector Comments: No vegetation was impeding the flow of the channel.

View of the channel looking upstream during 2016 inspection.

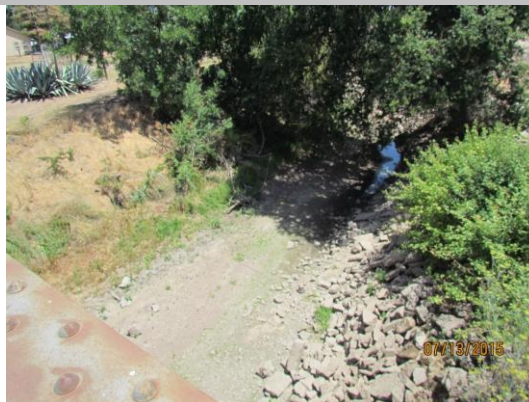
Photo 2 of 2 : CH_2016_NA0017_44_21_20160720_00007.jpg

View of the channel looking upstream during 2015 inspection.

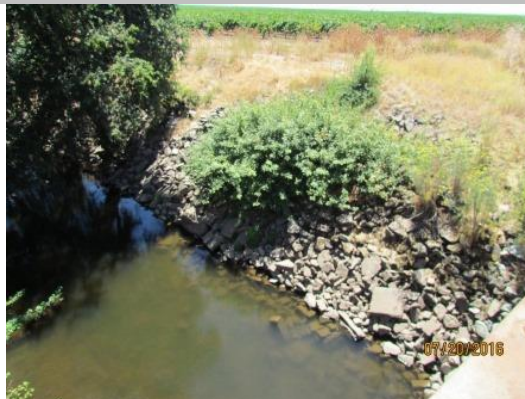
Photo 1 of 1 : CH_2016_NA0017_44_24_20160802_00063.jpg

Rating **	A	Issue No.	24	GPS Lat/Long
Issue Type +	Ma	Location *		37.925330 °
Category	Rivers, Channels & Designated Flood			-121.000120 °
Item	Revetments			
DWR ID	DWR_NA0017_44_c_2012_24			
Action/Comments				
Inspector Comments: Existing riprap is properly maintained.

Existing revetments are properly maintained looking upstream of the channel.

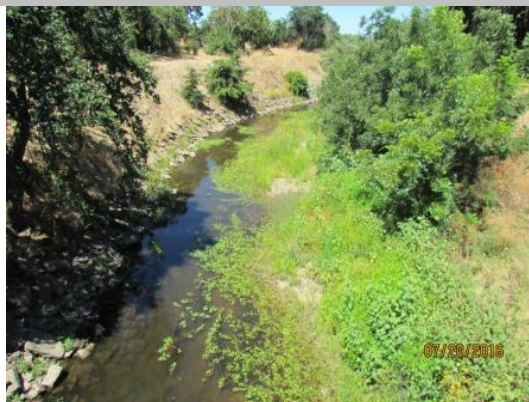
Photo 1 of 2 : CH_2016_NA0017_44_26_20160802_00064.jpg

Rating **	A	Issue No.	26	GPS Lat/Long
Issue Type +	Ma	Location *		37.925330 °
Category	Rivers, Channels & Designated Flood			-121.000120 °
Item	Vegetation & Obstructions			
DWR ID	DWR_NA0017_44_c_2012_26			
Action/Comments				
Inspector Comments: Minimal vegetation was found in the channel.

View of the channel looking downstream during 2016 inspection.

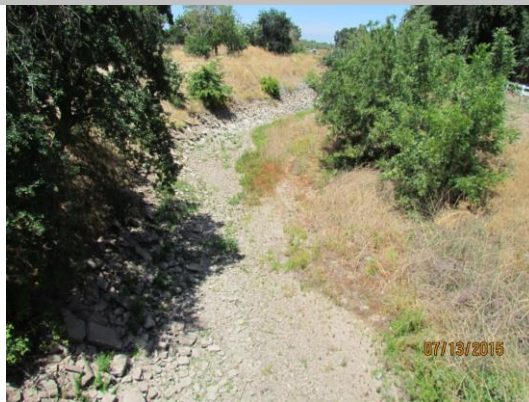
Photo 2 of 2 : CH_2016_NA0017_44_26_20160720_00011.jpg

View of the channel looking downstream during 2015 inspection.

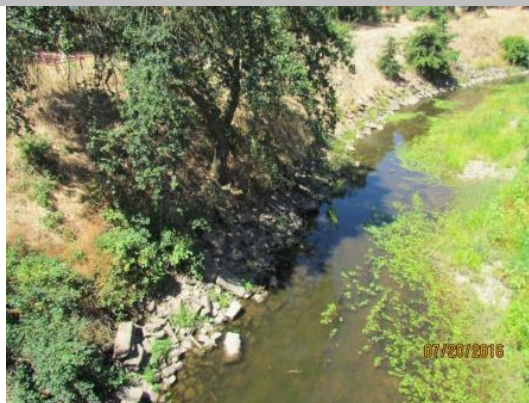
Photo 1 of 2 : CH_2016_NA0017_44_29_20160802_00065.jpg

Rating **	A	Issue No.	29	GPS Lat/Long
Issue Type +	Ma	Location *		37.925330 °
Category	Rivers, Channels & Designated Flood			-121.000120 °
Item	Revetments			
DWR ID	DWR_NA0017_44_c_2012_29			
Action/Comments				
Inspector Comments: Existing riprap is properly maintained.

View of the revetments on the left of the channel looking downstream during 2016 inspection.

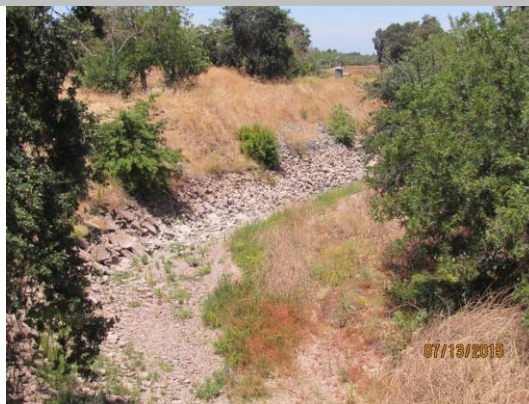
Photo 2 of 2 : CH_2016_NA0017_44_29_20160720_00013.jpg

Inspector Comments: Existing riprap is properly maintained.

View of the revetments on the left of the channel looking downstream.

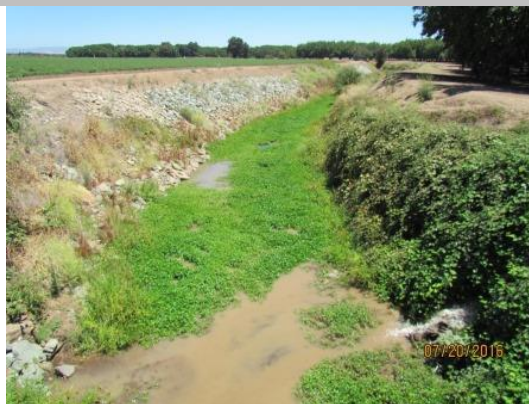
Photo 1 of 2 : CH_2016_NA0017_44_31_20160802_00066.jpg

Rating **	A	Issue No.	31 (cont)	GPS Lat/Long
Issue Type +	Ma	Location *		37.920060 °
Category	Rivers, Channels & Designated Flood			-121.027790 °
Item	Vegetation & Obstructions			
DWR ID	DWR_NA0017_44_c_2012_31

View of the channel looking upstream during 2016 inspection.

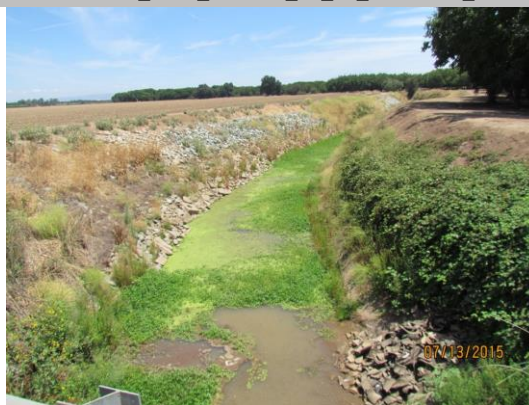
Photo 2 of 2 : CH_2016_NA0017_44_31_20160720_00015.jpg

View of the channel looking upstream during 2015 inspection.

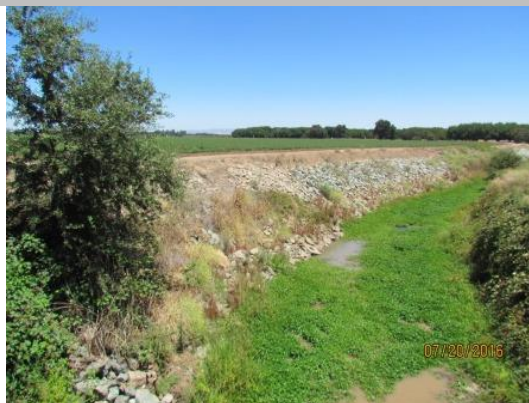
Photo 1 of 1 : CH_2016_NA0017_44_34_20160802_00067.jpg

Inspector Comments: Existing revetments were maintained properly on the channel bank.

View of the existing revetments on the right channel bank looking upstream.

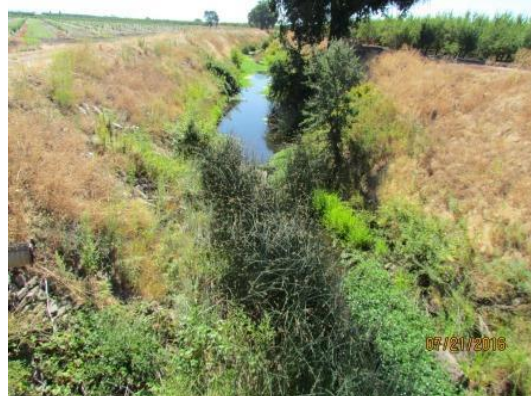
Photo 1 of 1 : CH_2016_NA0017_44_41_20160802_00069.jpg

Inspector Comments: Significant amounts of cat tails were present in the channel.

View of the vegetation on the channel looking upstream during 2016 inspection.

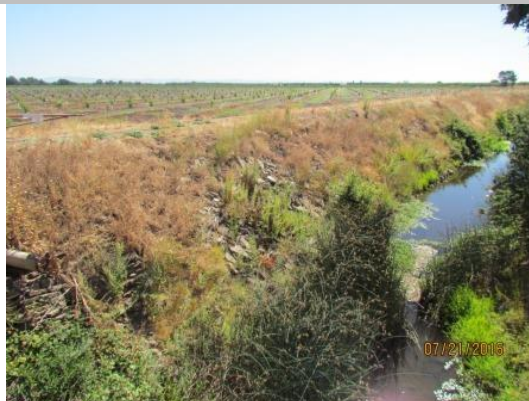
Photo 1 of 1 : CH_2016_NA0017_44_44_20160802_00070.jpg

Rating **	A	Issue No.	44	GPS Lat/Long
Issue Type +	Ma	Location *		37.913060 °
Category	Rivers, Channels & Designated Flood			-121.056230 °
Item	Revetments			
DWR ID	DWR_NA0017_44_c_2012_44			
Action/Comments				
Inspector Comments: Existing riprap protection is properly maintained.

View of existing revetments on the channel bank looking upstream.

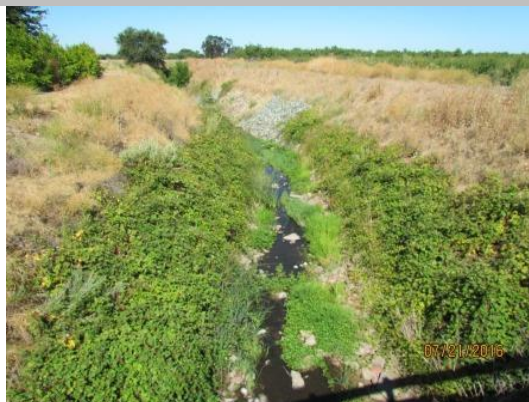
Photo 1 of 2 : CH_2016_NA0017_44_46_20160802_00071.jpg

Inspector Comments: The vegetation growth around the channel is not impeding the flow.

View of the vegetation on the channel looking downstream during 2016 inspection.

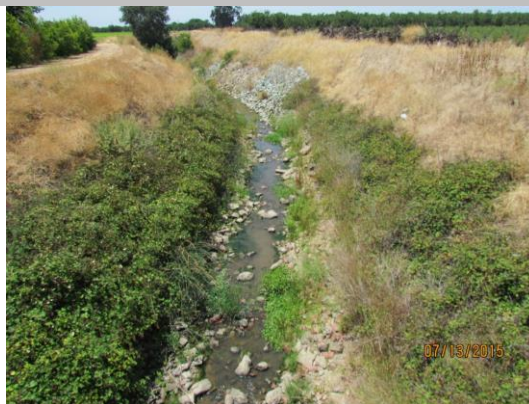
Photo 2 of 2 : CH_2016_NA0017_44_46_20160720_00021.jpg

Inspector Comments: The vegetation growth around the channel is not impeding the flow.

View of the channel looking downstream.

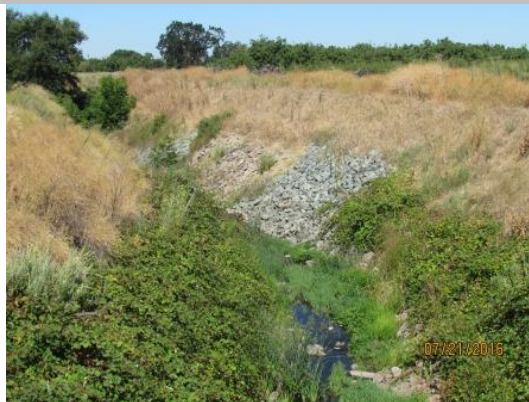
Photo 1 of 1 : CH_2016_NA0017_44_49_20160802_00072.jpg

Inspector Comments: Existing riprap protection is properly maintained.

View of the existing revetments looking downstream.

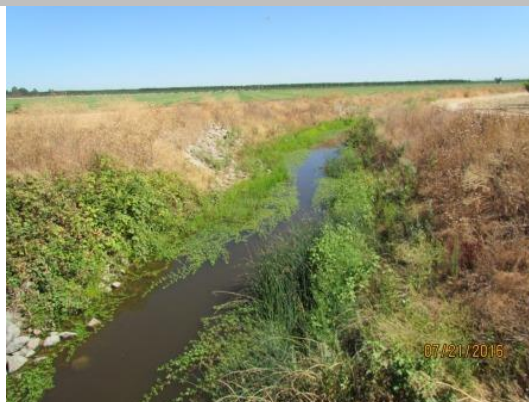
Photo 1 of 1 : CH_2016_NA0017_44_51_20160802_00073.jpg

Rating **	A	Issue No.	51	GPS Lat/Long
Issue Type +	Ma	Location *		37.895050 °
Category	Rivers, Channels & Designated Flood			-121.118200 °
Item	Vegetation & Obstructions			
DWR ID	DWR_NA0017_44_c_2012_51			
Action/Comments				
Inspector Comments: Minimal vegetation is present in the channel.

View of the vegetation on the upstream of the channel.

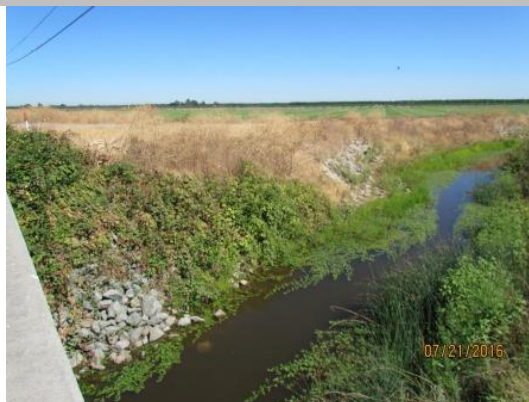
Photo 1 of 1 : CH_2016_NA0017_44_151_20160802_00074.jpg

Inspector Comments: Existing revetments are properly maintained.

View of the existing revetments on the upstream of the channel.

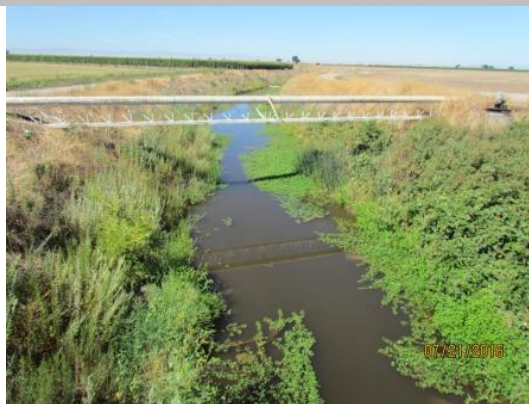
Photo 1 of 2 : CH_2016_NA0017_44_56_20160802_00075.jpg

Inspector Comments: Vegetation and some waddy vegetation was present on the channel, but it may not impede the flow of the channel.

View of the vegetation on the channel looking downstream during 2016 inspection.

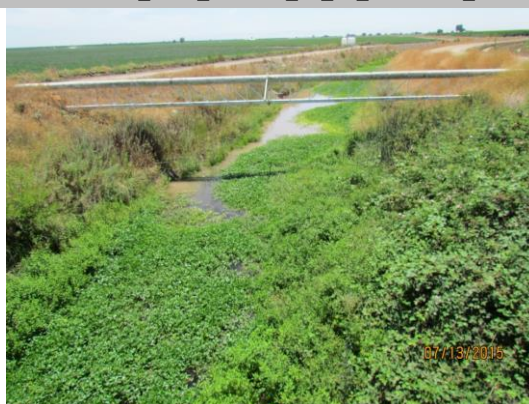
Photo 2 of 2 : CH_2016_NA0017_44_56_20160720_00024.jpg

View of the vegetation on the channel looking downstream.

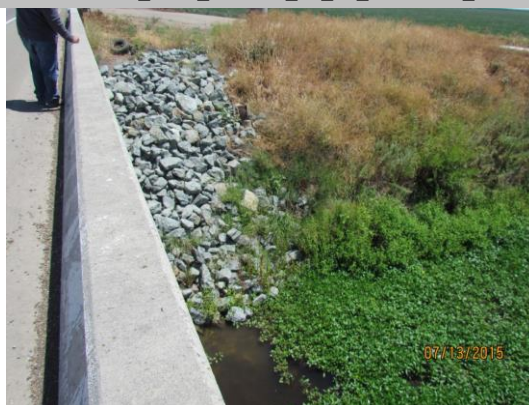
Photo 1 of 1 : CH_2016_NA0017_44_59_20160720_00025.jpg

Inspector Comments: Existing revetments appears to be undamaged.

View of existing revetments on the channel banks looking downstream.

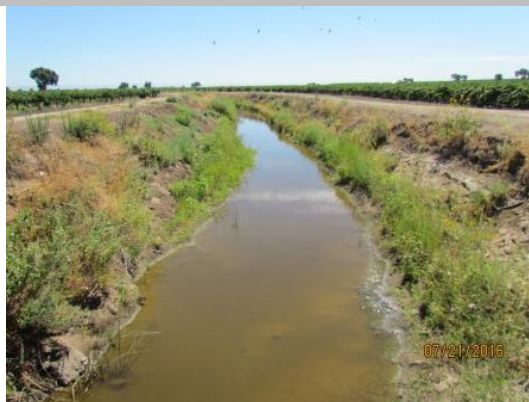
Photo 1 of 2 : CH_2016_NA0017_44_61_20160802_00076.jpg

Inspector Comments: Minimal vegetation was present in the channel.

View of the channel looking upstream during 2016 inspection.

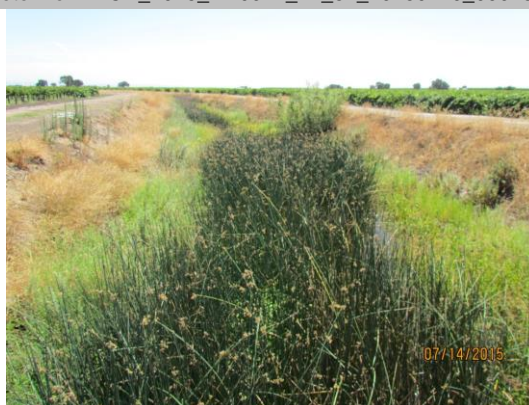
Photo 2 of 2 : CH_2016_NA0017_44_61_20160720_00026.jpg

View of the vegetation on the upstream of the channel.

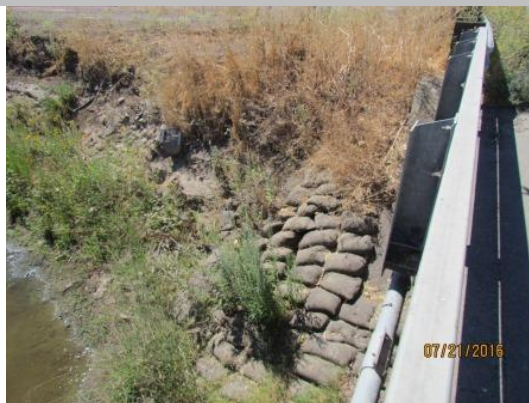
Photo 1 of 1 : CH_2016_NA0017_44_64_20160802_00077.jpg

Inspector Comments: Existing riprap protection is properly maintained.

View of existing riprap on the upstream of the channel.

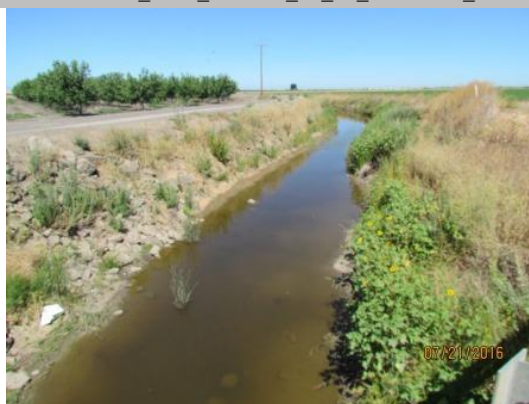
Photo 1 of 2 : CH_2016_NA0017_44_66_20160802_00078.jpg

Inspector Comments: Minimal vegetation was present on the channel.

View of the channel looking downstream during 2016 inspection.

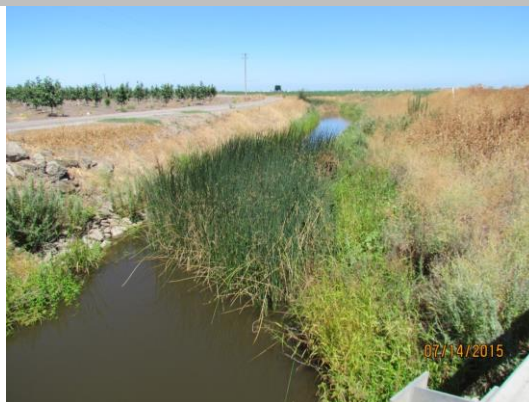
Photo 2 of 2 : CH_2016_NA0017_44_66_20160720_00028.jpg

Rating **	A	Issue No.	66 (cont)	GPS Lat/Long
Issue Type +	Ma	Location *		37.880726 °
Category	Rivers, Channels & Designated Flood			-121.146929 °
Item	Vegetation & Obstructions			
DWR ID	DWR_NA0017_44_c_2012_66			
Action/Comments				
Inspector Comments: Minimal vegetation was present on the channel.

View of the vegetation in the channel looking downstream.

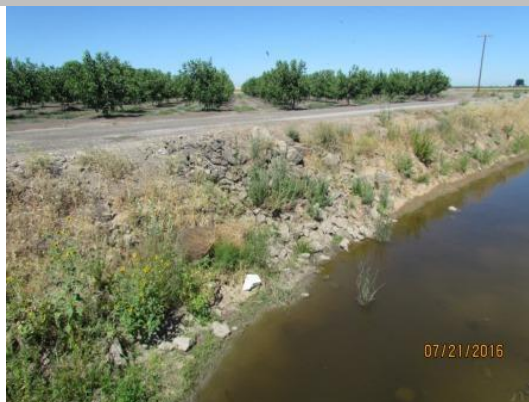
Photo 1 of 1 : CH_2016_NA0017_44_69_20160802_00079.jpg

Inspector Comments: Existing riprap protection is properly maintained.

View of the existing riprap on the channel bank looking downstream.

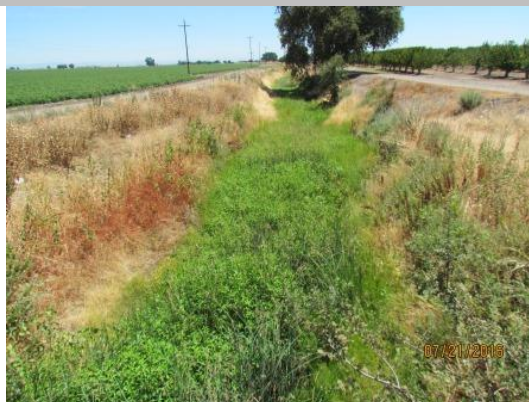
Photo 1 of 1 : CH_2016_NA0017_44_71_20160803_00080.jpg

Inspector Comments: Minimal vegetation is present in the channel, but the flow is not impeded.

View of vegetation on the upstream side of the channel.

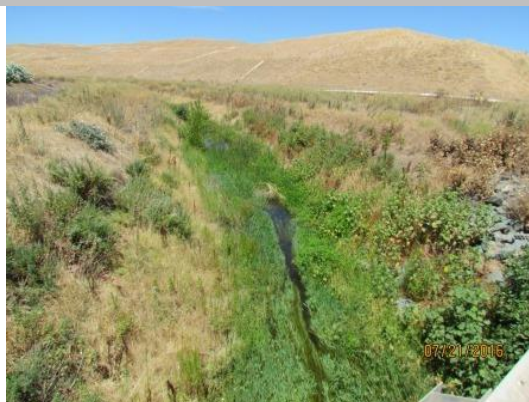
Photo 1 of 2 : CH_2016_NA0017_44_76_20160803_00081.jpg

Check Point / View				
Austin Rd / Down				
Rating **	A	Issue No.	76	GPS Lat/Long
Issue Type +	Ma	Location *		37.872482 °
Category	Rivers, Channels & Designated Flood			-121.182910 °
Item	Vegetation & Obstructions			
DWR ID	DWR_NA0017_44_c_2012_76			
Action/Comments				
Inspector Comments: Minimal vegetation growth is found, but it doesn't appear to impede the flow of the channel.

View of the vegetation on the downstream of the channel during 2016 inspection.

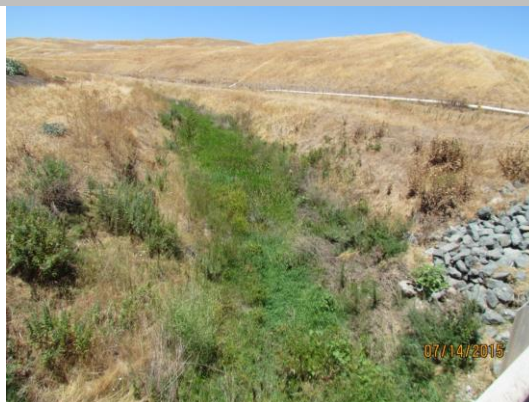
Photo 2 of 2 : CH_2016_NA0017_44_76_20160720_00032.jpg

Inspector Comments: Minimal vegetation growth is found, but it doesn't appear to impede the flow of the channel.

View of the vegetation on the downstream end of the channel.

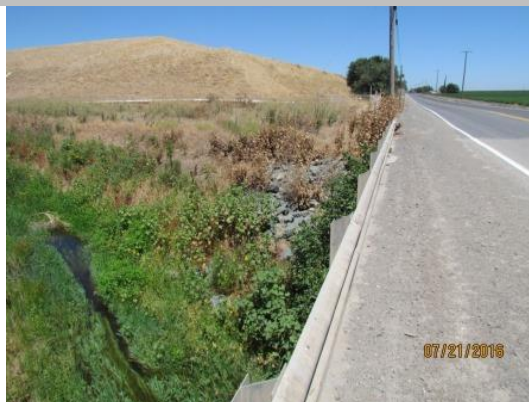
Photo 1 of 1 : CH_2016_NA0017_44_79_20160803_00082.jpg

Inspector Comments: Existing revetments are properly maintained.

View of the revetments on the downstream of the channel.

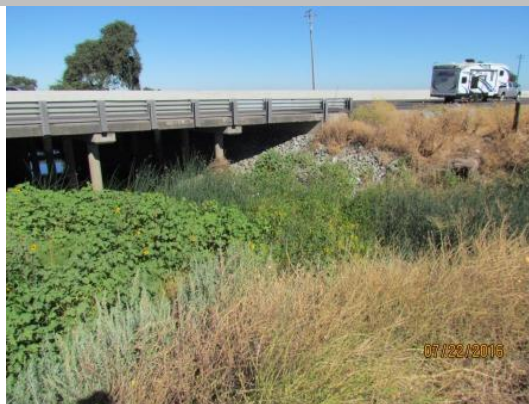
Photo 1 of 2 : CH_2016_NA0017_44_81_20160803_00085.jpg

Rating **	M	Issue No.	81	GPS Lat/Long
Issue Type +	Ma	Location *		37.872077 °
Category	Rivers, Channels & Designated Flood			-121.219318 °
Item	Vegetation & Obstructions			
DWR ID	DWR_NA0017_44_c_2012_81			
Action/Comments				
Inspector Comments: Vegetation growth may impede the flow of the channel.

View of the vegetation looking upstream of the channel during 2016 inspection.
